BUREAU OF SHIPS
TECHNICAL INSPECTION REPORT.

OPERATION CROSSROADS.
U.S.S. FALLON (APA 81).

TEST BAKER.

VOLUME 2 [U].

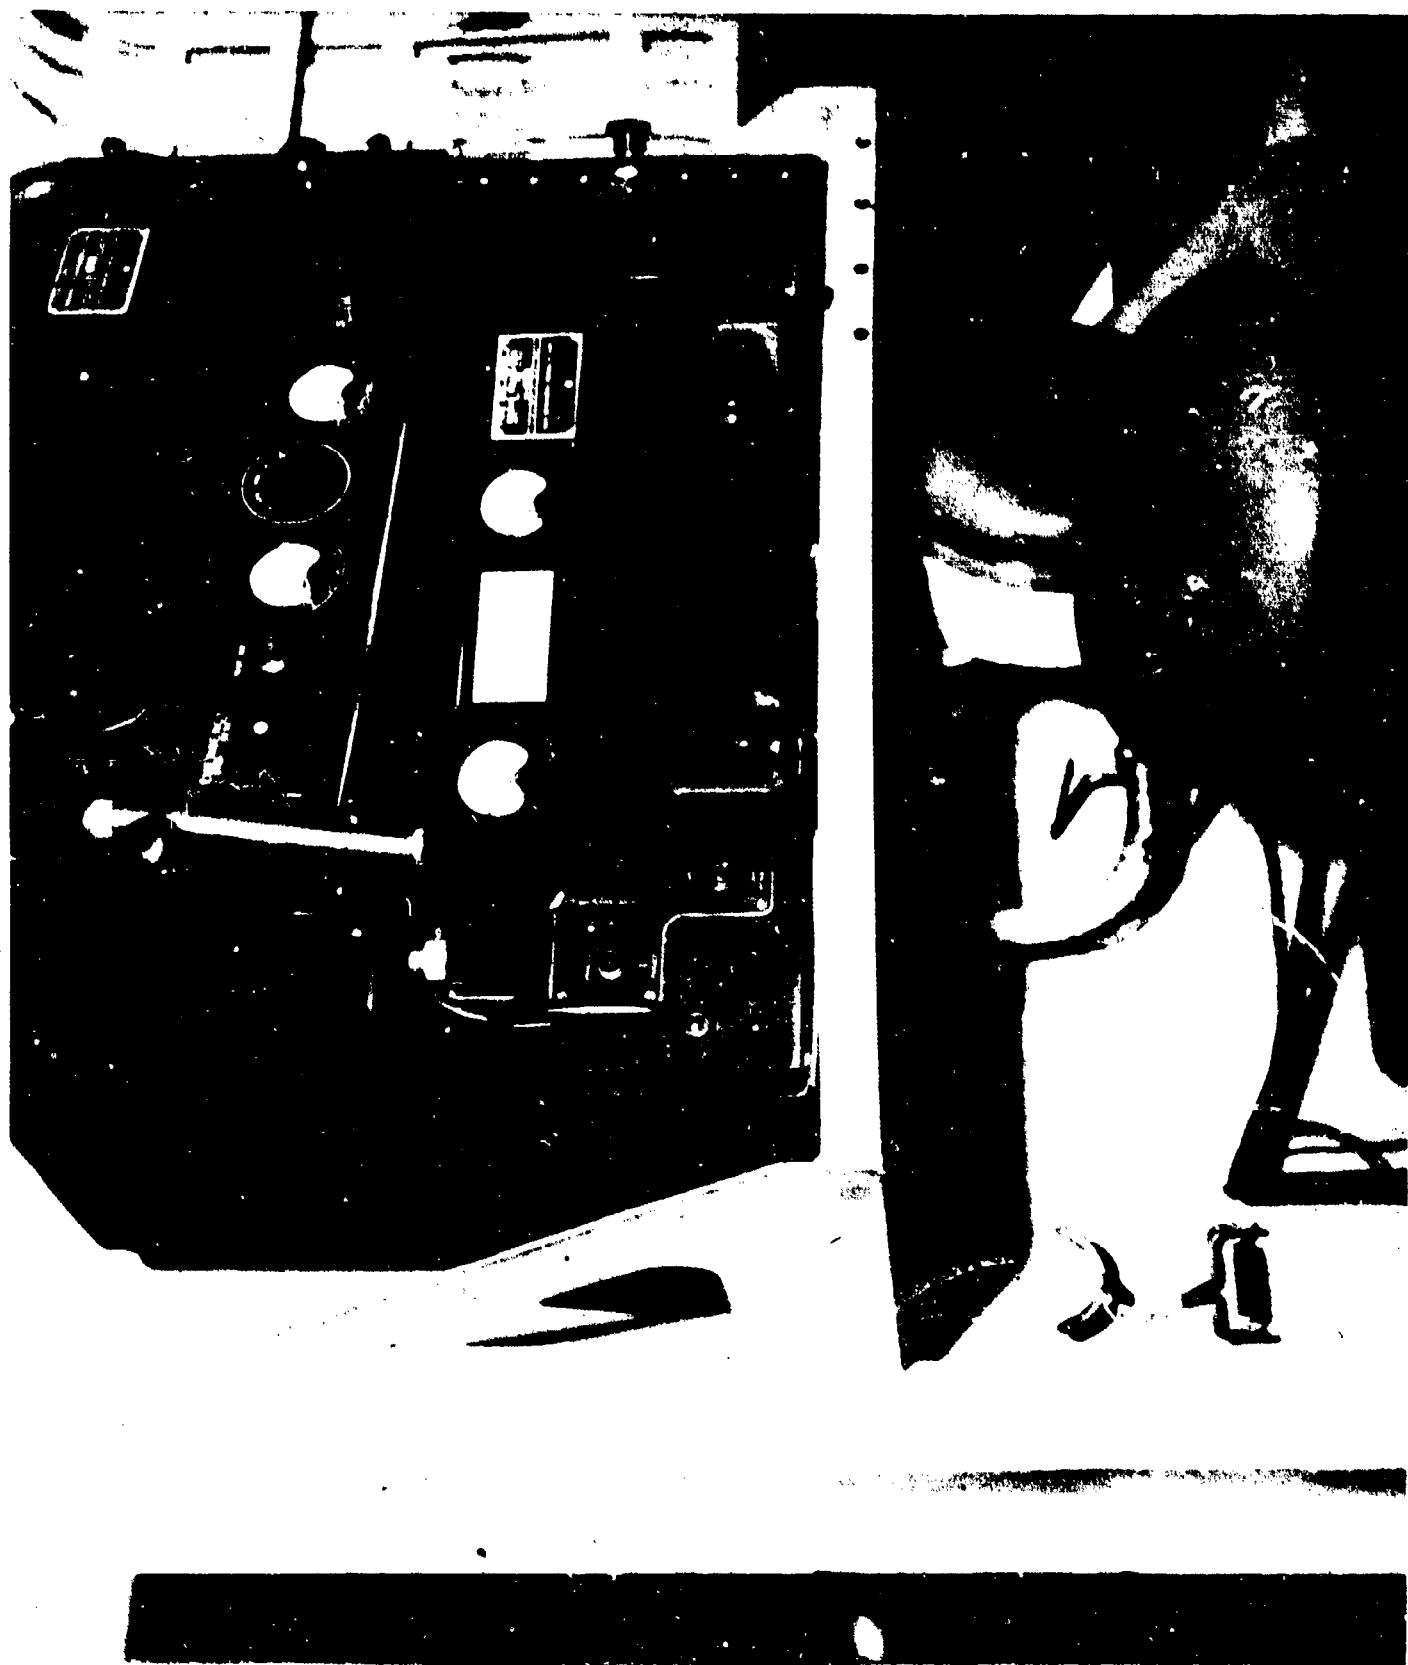
AB-CR-100-4206-12. Showing shock damage in radio central.

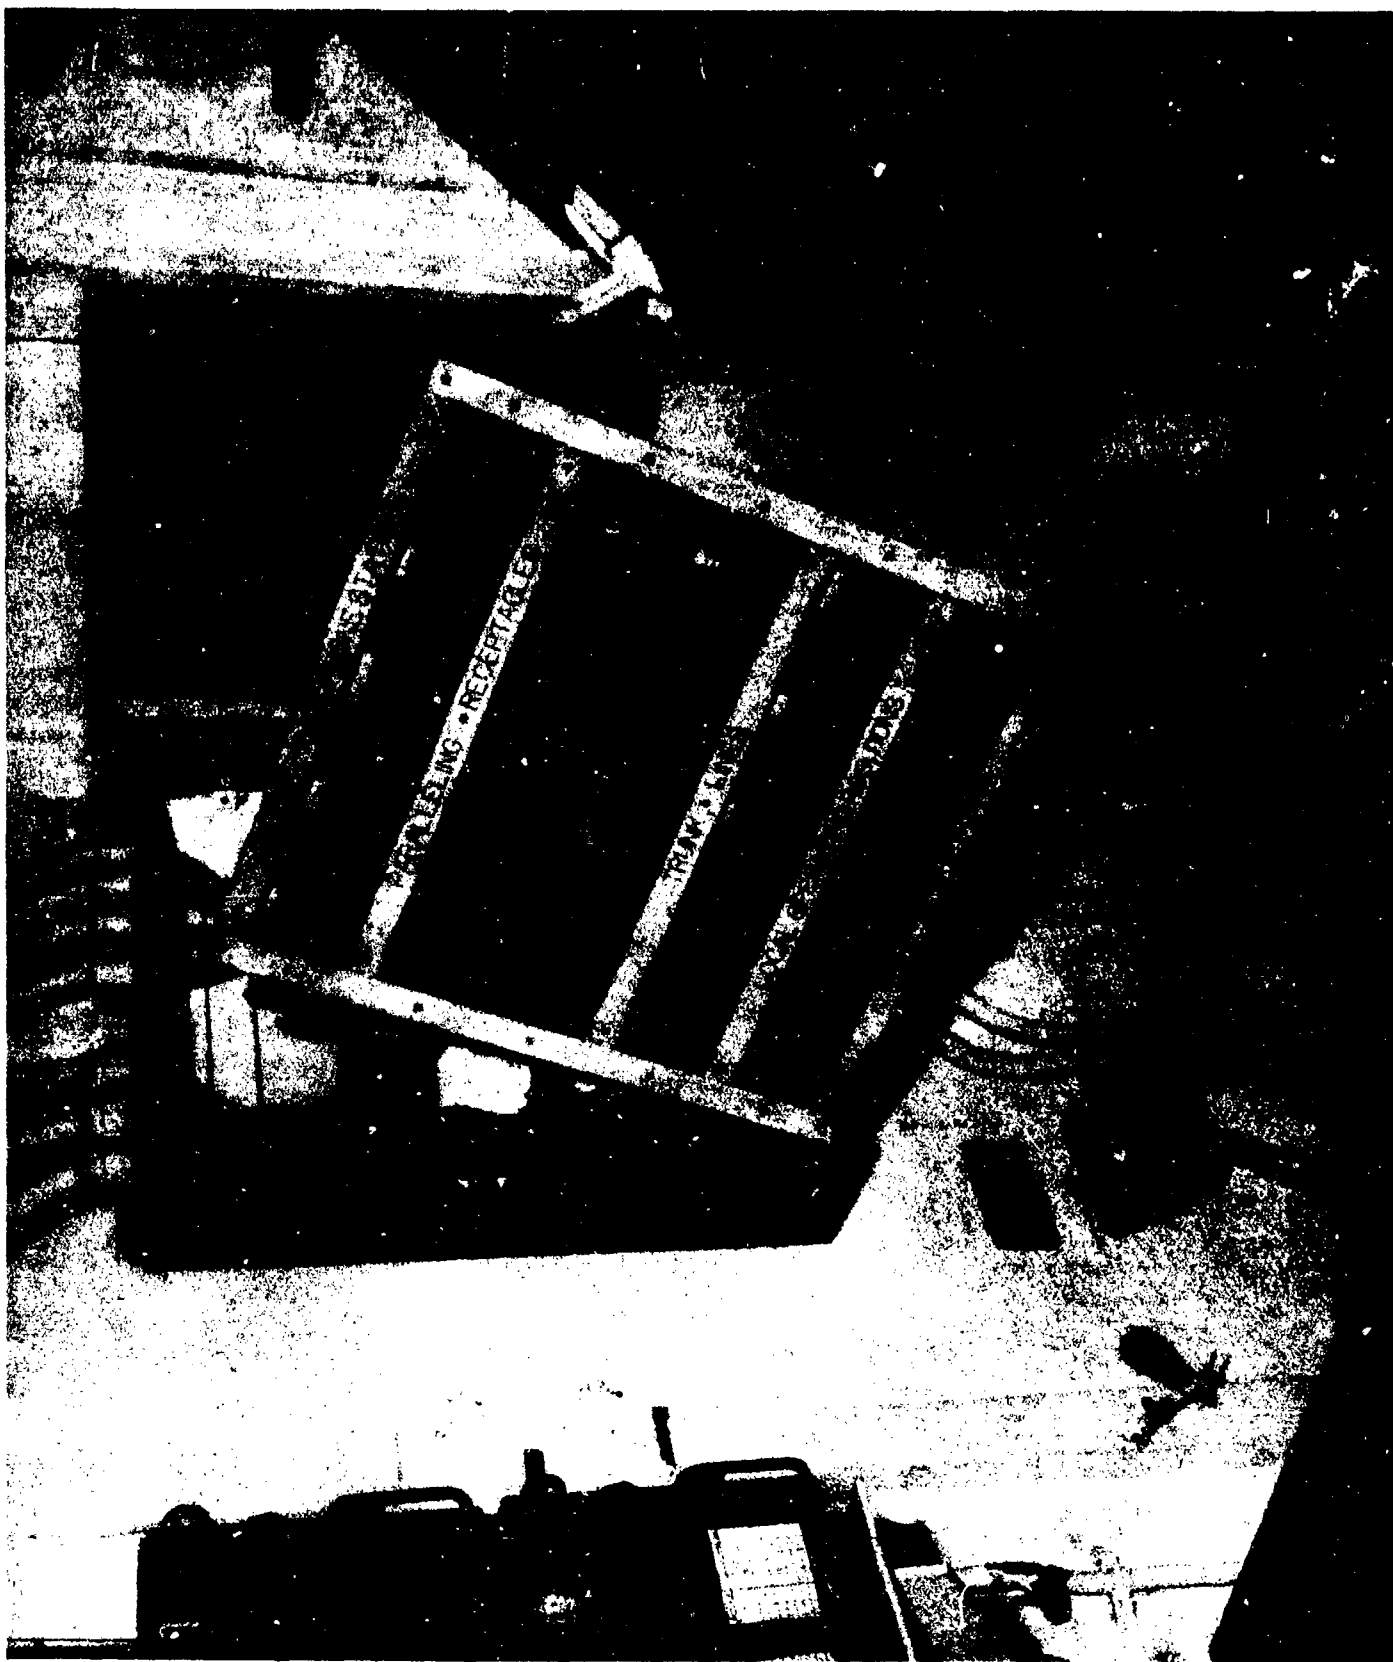
AB-CR-100-4206-10. View of general damage in radio central.

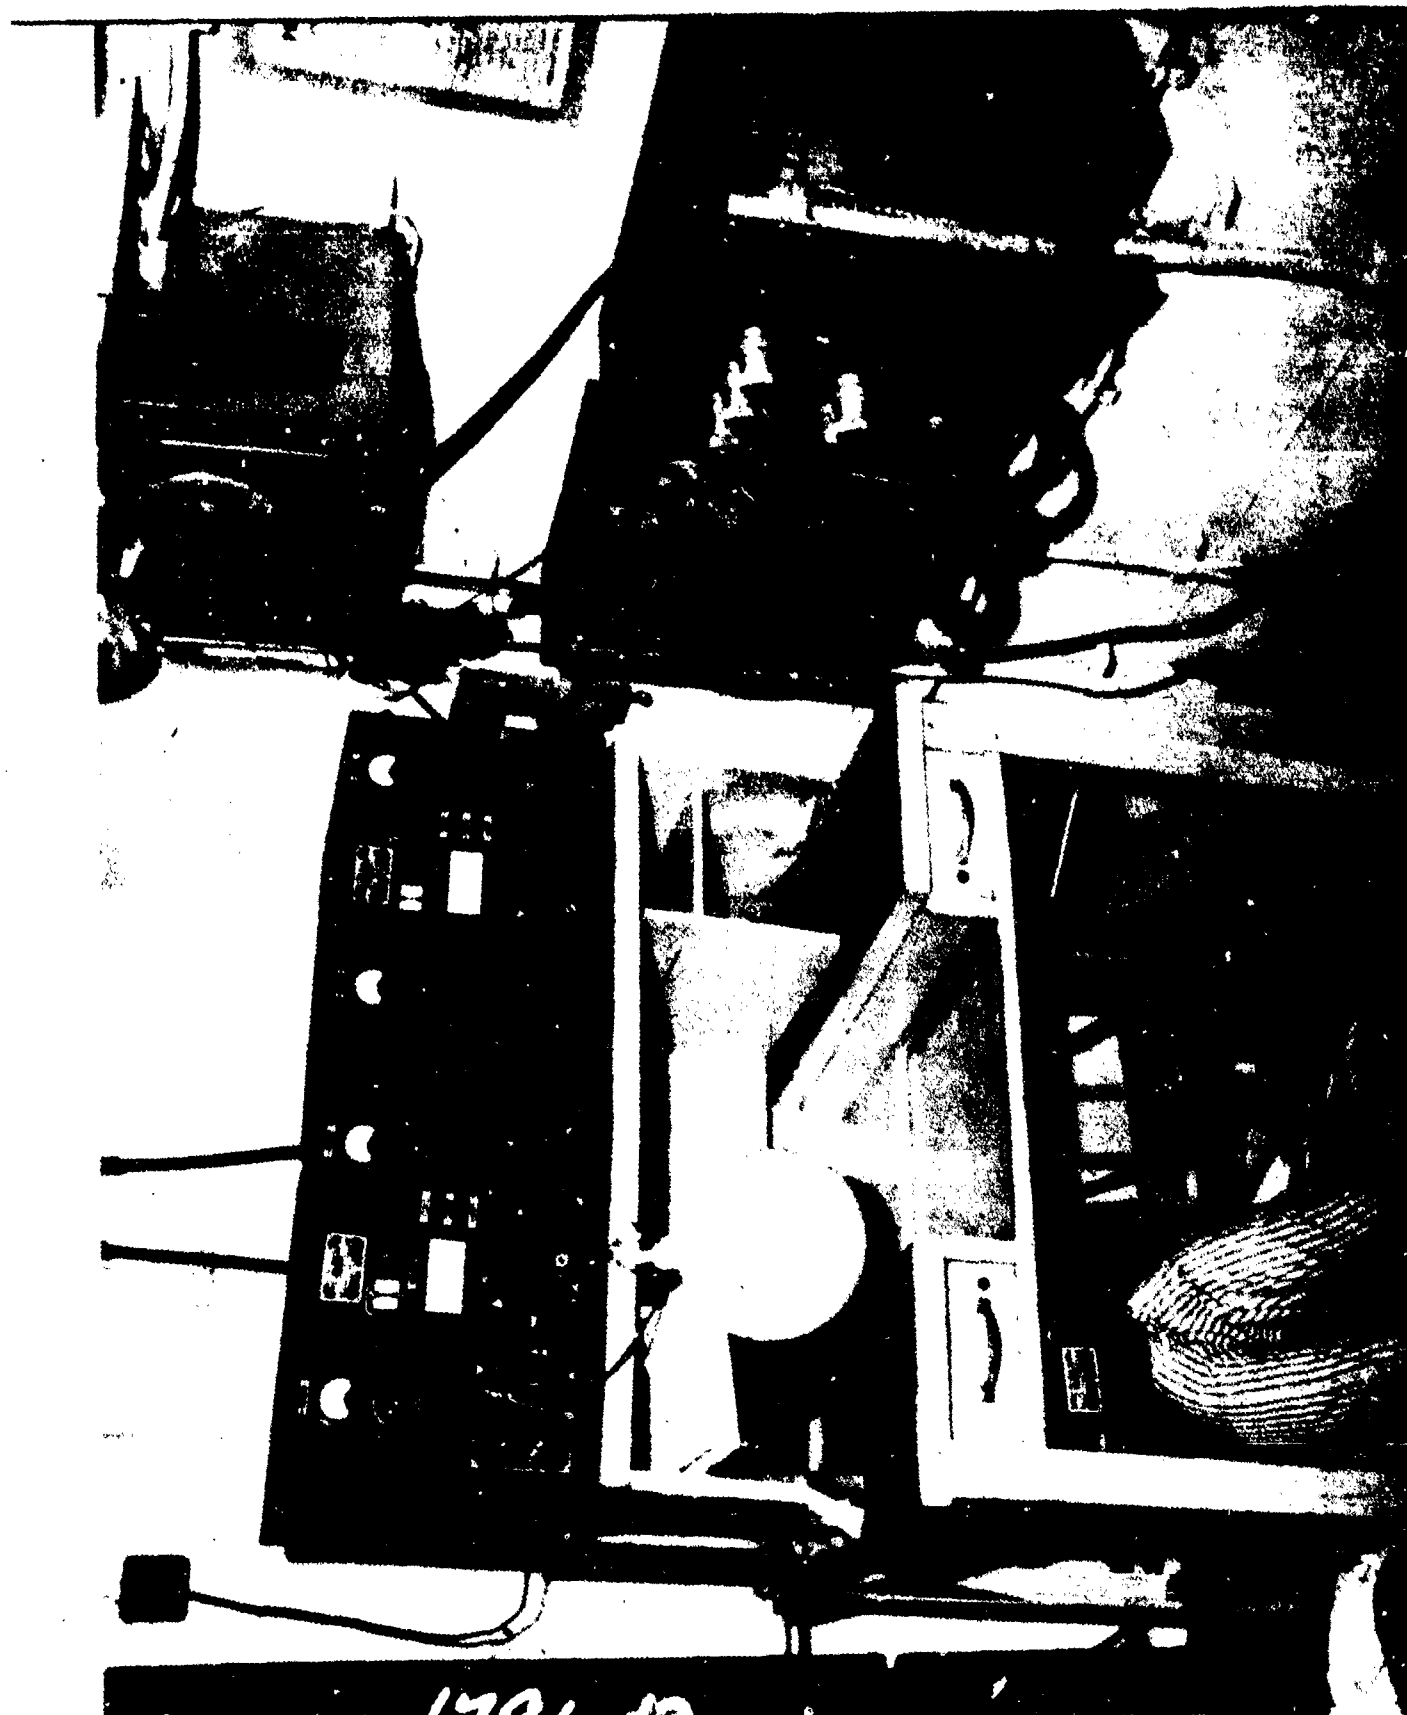
AB-CR-100-1791-12. View of damage in after radio room.

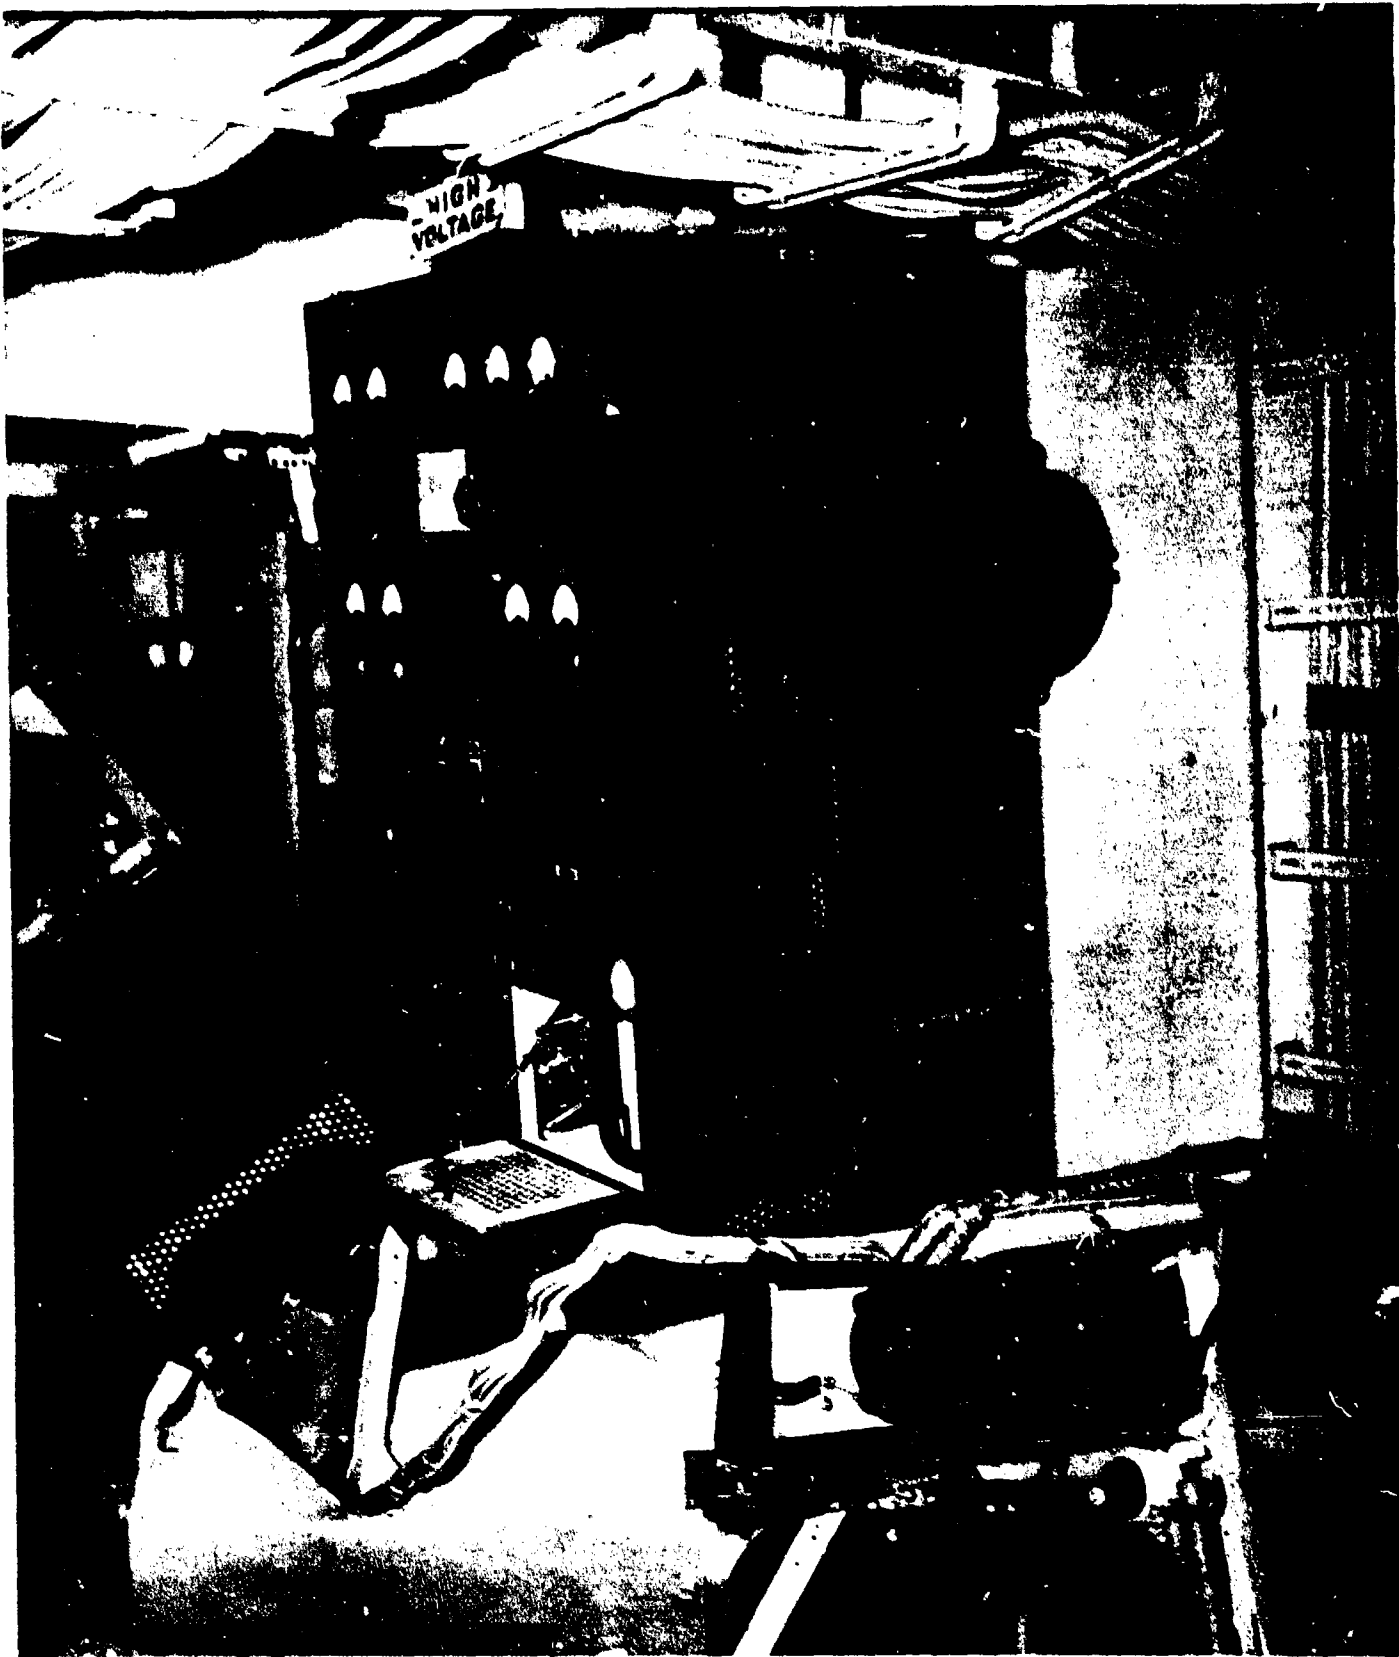
AB-CR-100-4206-8. View of general damage in radio central.

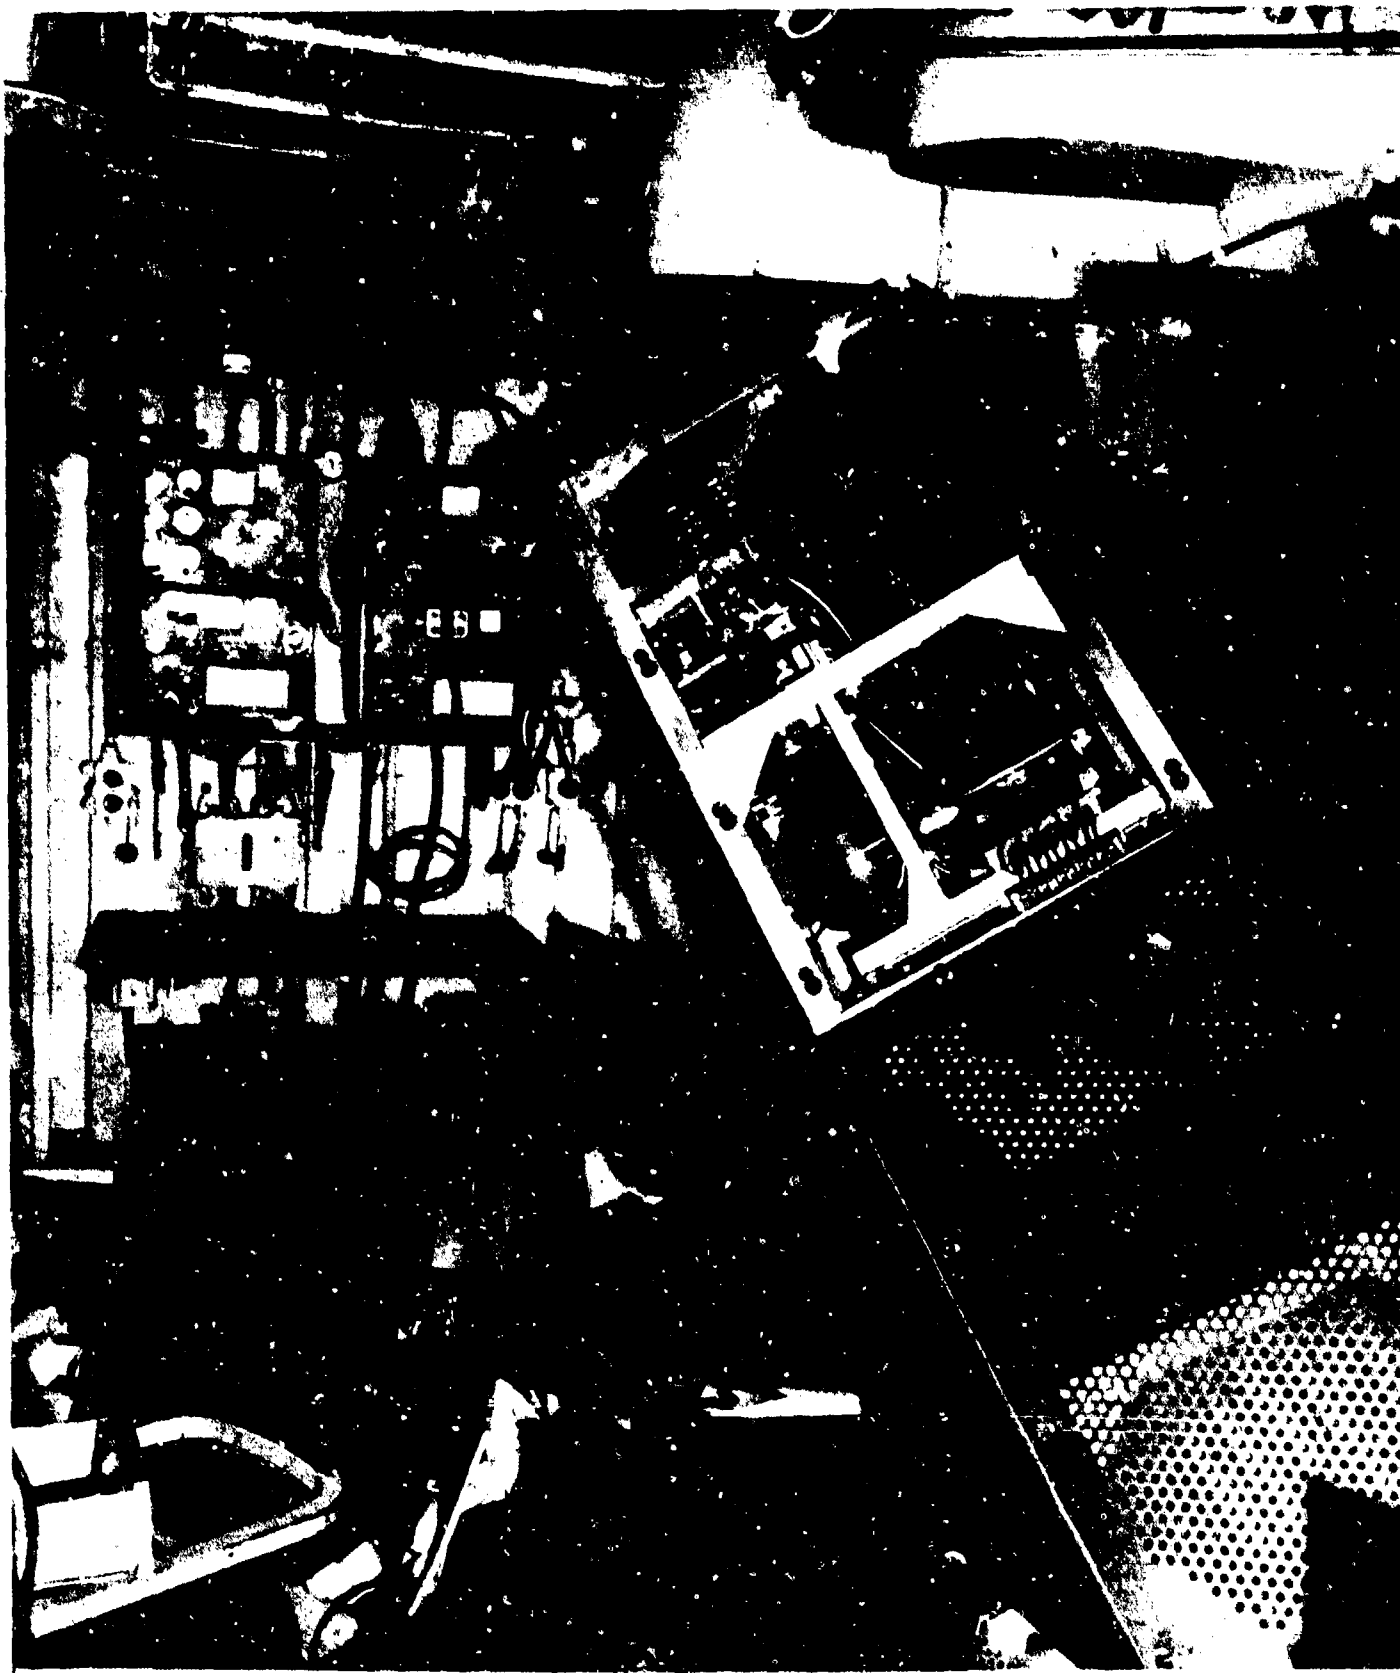
AB-CR-100-4206-9. View of general damage in radio central.
